Main Wharf
Construction Period: Jan – Nov 2016

Fatumaru Bay Park
Construction Period: Jan – Nov 2016

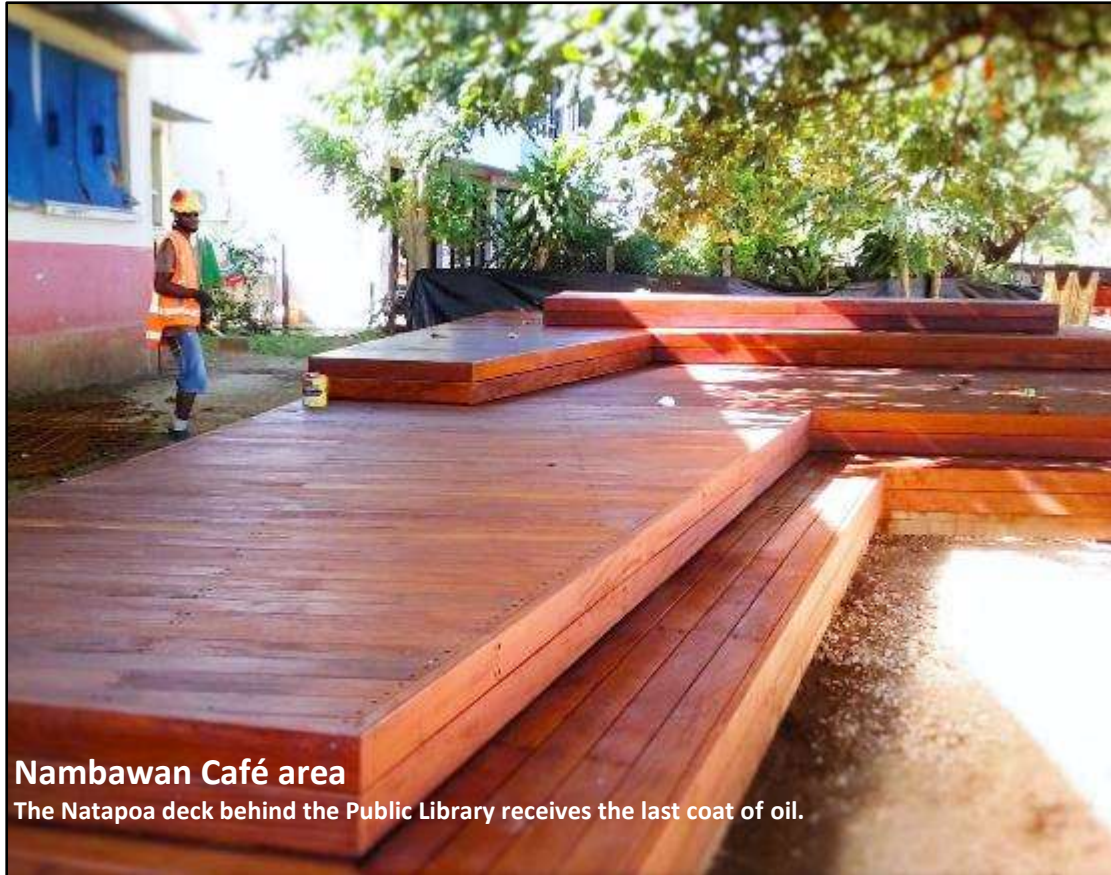
Nambawan Café area
The Natapoa deck behind the Public Library receives the last coat of oil.

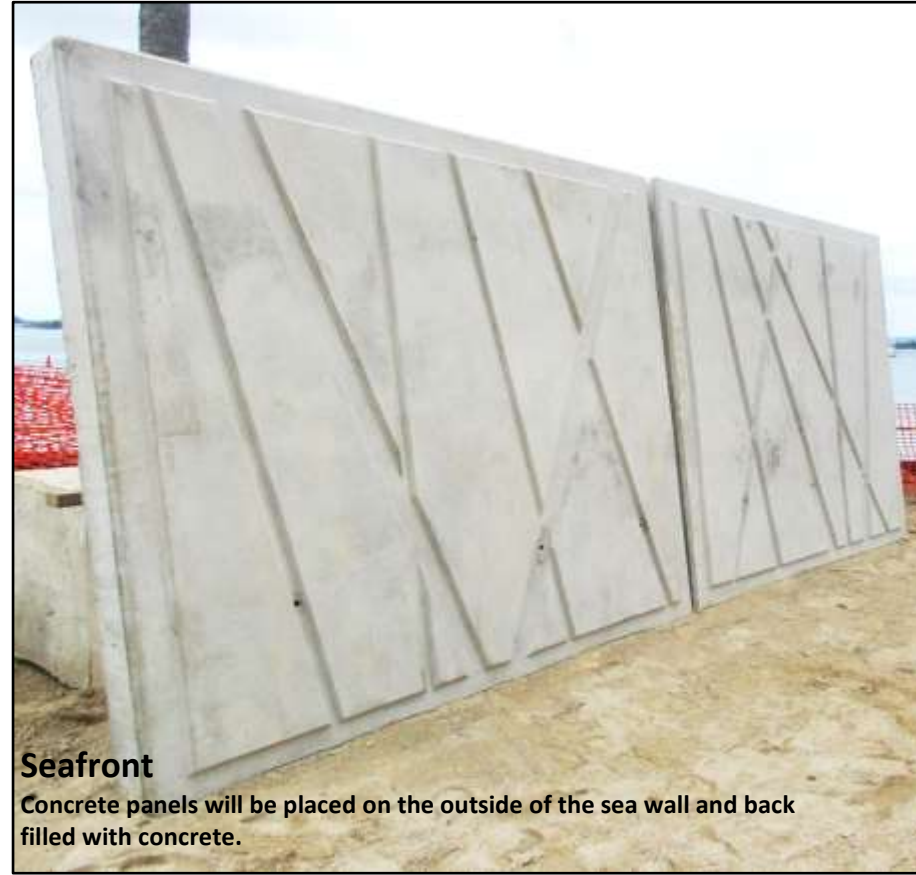
Seafront
Concrete panels will be placed on the outside of the sea wall and back filled with concrete.

Concrete Sea Wall Panels

The project includes the refurbishment of almost 485-meters of the sea wall. Considering the storm events that have hit Vanuatu the seawall is in a reasonable condition for refurbishment. The current works will strengthen the sea wall against future storm events and this requires a significant amount of work and a new methodology for Vanuatu.

The process involves:

- excavating on the landside of the current sea wall to install reinforcing in preparation for hanging the concrete panels (see above) and in-situ concrete
- cleaning the rust off the current sheet piles to prepare a good surface for the concrete that will then be poured on both sides of the seawall sheet piles
- cutting off the concrete beam on the top of the sea wall so that the concrete panels can be placed on the sea side of the seawall
- place the concrete panels in alignment and pour concrete between the panel and the current seawall sheet piles
- install a new concrete beam on top of the concrete panels.

There are approximately 250 panels to be made and installed and they are generally 2.1mtrs x 2.4mtrs in size.
