FINAL Initial Environmental Evaluation (IEE) of Eastern Subprojects

Cyclone Pam Road Reconstruction
Project

Prepared for
Ministry of Infrastructure and Public Utilities
20 January 2017

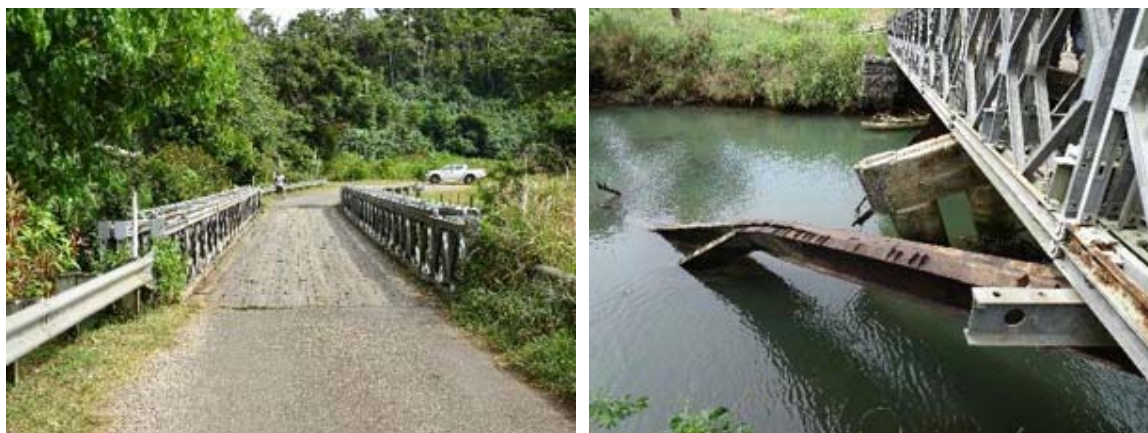
Figure 3-2 Epule bridge

Local villagers report that the bridge was overtopped by floodwaters to a depth of about 1 m following TC Pam but receded after approximately one hour. The local villagers further report that the bridge is overtopped about twice a year.

It is noted that the original bridge collapsed in 2015 as a consequence of TC Pam and the partial remains of the centre pier and sections of steel beam are still visible above the waterline at the northern end.

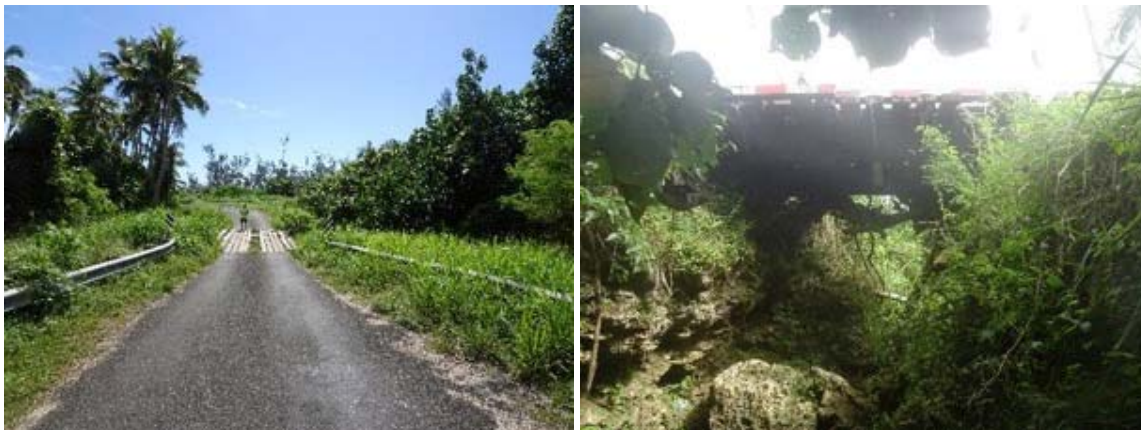
Figure 3-3 Lamin Bridge

Local villagers report that Lamin Bridge was affected by TC Pam with the bridge being overtopped by floodwaters to a depth of about 1 m, however, the floodwaters receded after a period of about 12 hours. Debris blockage was said to be a major contributor to the flooding as a result of the reduction in the waterway area under the bridge. The villagers stated that in a typical year without a major cyclone, the bridge does not get overtopped.

The bridge has no footway or traffic barriers. Timber kerbs are provided along both edges of the bridge. The clear width between the kerbs is 2.4 m. It crosses a narrow, steep sided channel with a depth from bed level to beam soffit of approximately 4.2 m. At the time of the inspection, debris was observed to be snagged on the upstream side of the bridge and it was noted that the creek was not flowing. There are no utilities fixed to the structure.

The Vanuatu Impact Assessment Report prepared in April 2015 stated “Approach road was scoured at gabion wall protection and a wing wall was damaged. There was no impact on the bridge and its approaches due to Cyclone Pam.”

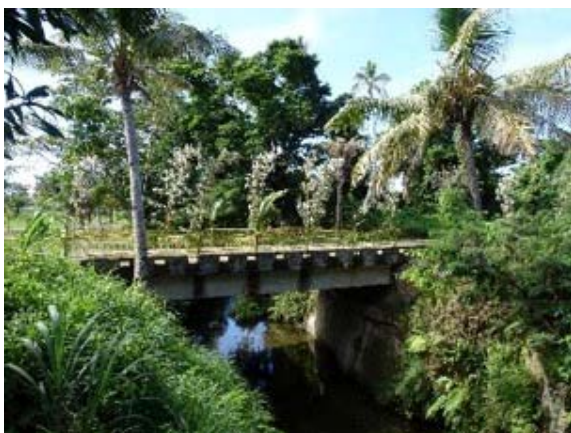
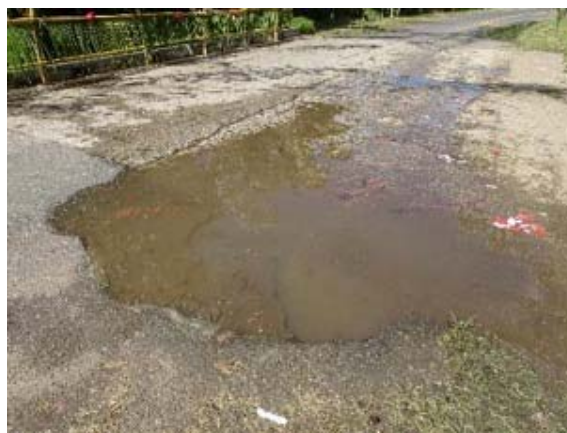
Figure 3-4 Pangpang Bridge

Local villagers report that Pangpang Bridge was overtopped by floodwaters to a depth of about 1 m as a result of TC Pam, however, the floodwaters receded during the night. The villagers stated that in a typical year without a major cyclone, Pangpang Bridge does not overtop.

No guardrail is provided on the bridge approaches or on the bridge and there is no footway. At the bridge site, the river is on a straight reach and there is negligible erosion of the banks. There also appears to be little or no scour at the abutments. There appear to be no utilities crossing the structure although this will need to be confirmed.

The Vanuatu Impact Assessment Report prepared in April 2015 stated “There was no impact on the bridge and its approaches due to Cyclone Pam.”

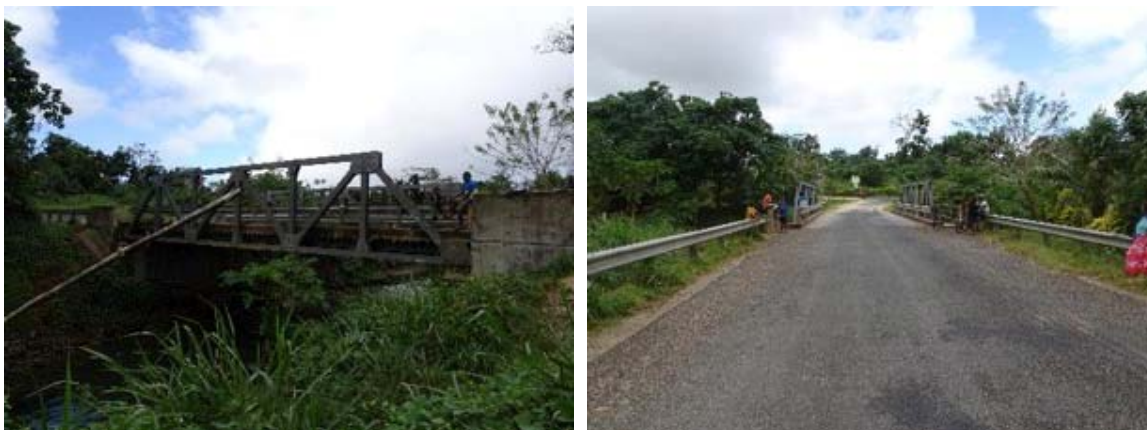
Figure 3-5 Rentapau Bridge

Rentapau Bridge was constructed in 2004 and is a single-span, two-lane, galvanised steel single through-truss "Eastbridge" comprising three (3) standard 4 m length bays. A 0.8 m clear width galvanised steel separated cantilevered footway is provided on the downstream side and a utility pipe is attached to the outside edge of the footway structure. The bridge is supported on concrete wall type abutments. The clear width of the carriageway is 6.5 m, kerb to kerb. On the bridge, W-beam guardrails are fixed to the truss members (providing no effective protection for the truss); guardrail is also provided on the bridge approaches. The deck slab is orthotropic with concrete cast onto a steel trough profile sheet. Gabion mattresses provide protection to the west abutment slopes, and gabion baskets are used for protection at the east abutment.

According to local villagers the bridge was not overtopped following TC Pam.

The Vanuatu Impact Assessment Report prepared in April 2015 stated “There was no impact on the bridge and its approaches due to Cyclone Pam.” However, it is noted that there is damage to the gabion baskets at the toe of the abutments, some damage to the gabion mattresses on the abutment slope and the east abutment is locally undermined. It is possible that these damages could have occurred as a consequence of the cyclone,

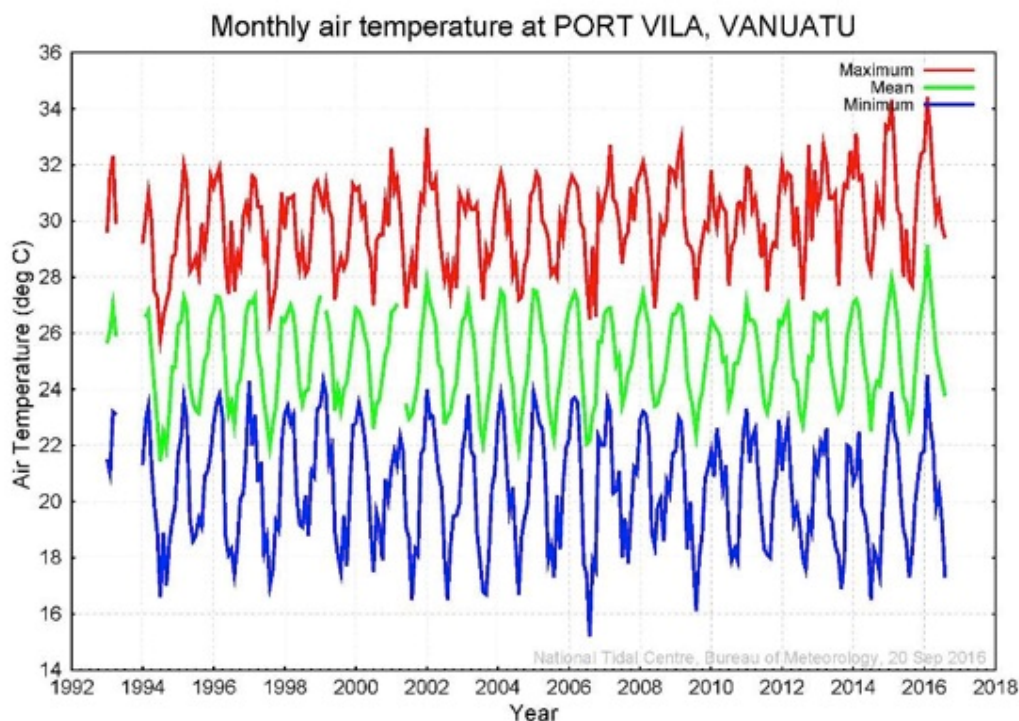
Figure 4-2 Monthly air temperatures in Port Vila, west Efate

Temperatures do not vary greatly throughout the year, given its geographical position near the equator. Air temperatures in Port Vila, on the western side of Efate, vary between an average of 23°C in August and 27°C in February. Monthly maximum, mean and minimum temperatures from 1992 to 2016 are illustrated in the Figure below. Temperatures are not collected on other areas of the island (Republic of Vanuatu, 2014).

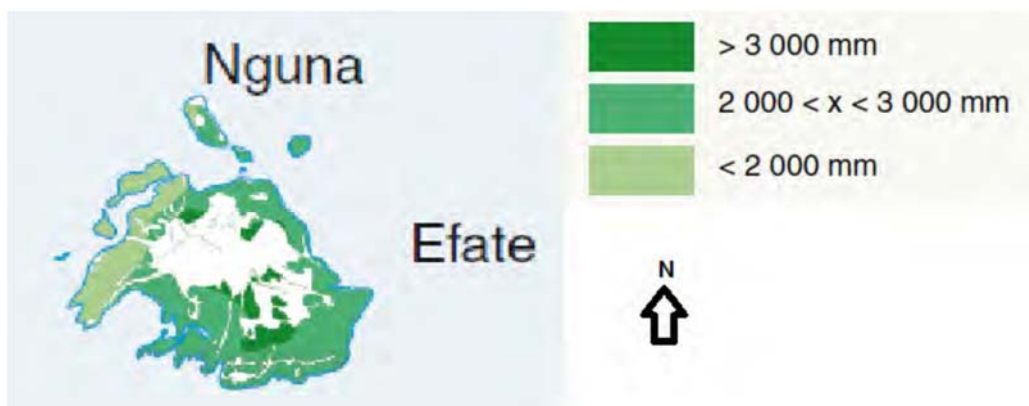
Figure 4-3 Rainfall pattern

Rainfall distribution patterns across Vanuatu is determined by seasonal wind flow, topographic features (i.e. rain shadow effects) and the South Pacific Convergence Zone (SPCZ). During the wet (hot) season, rainfall is higher on the southeast, the windward side. On Efate, annual rainfall ranges from 2400-3000 mm on the east and is almost half that amount on the leeward/west side. The wettest month in Vanuatu is usually March and the driest month is August (Government of Vanuatu, 2014).

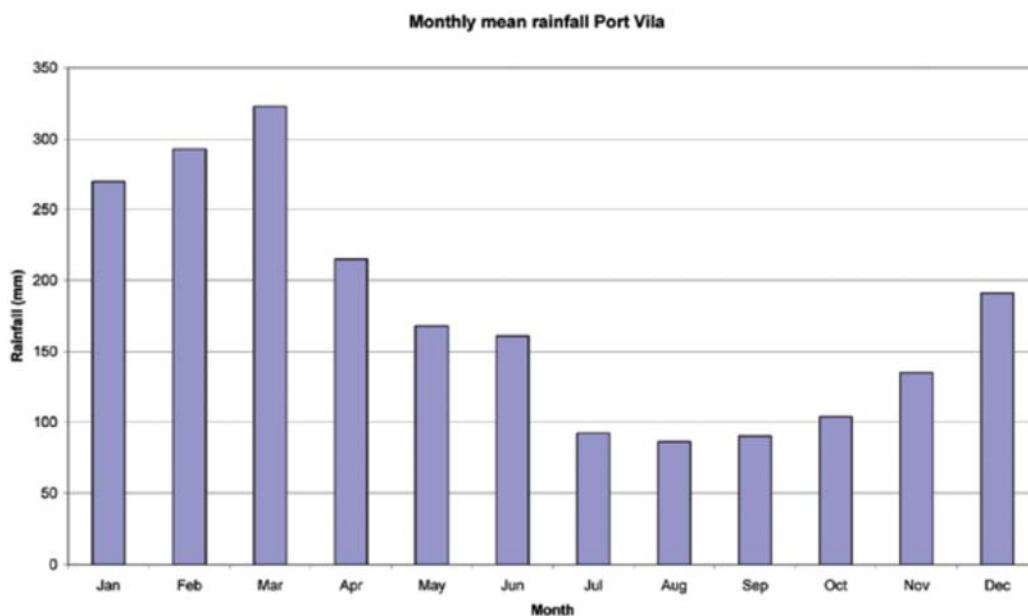
Figure 1-2 Mean rainfall, Port Vila

Mean rainfall in Port Vila, in the south west of the island) is presented in the figure below. The wettest month in Vanuatu is usually March and the driest month is August.

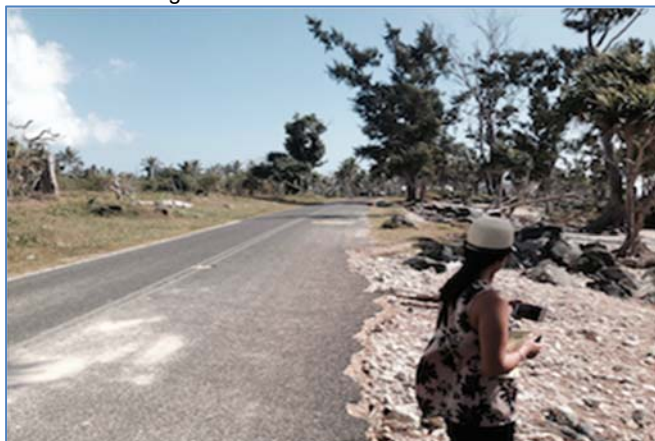
Sub project	Physical environment	Biological environment	Socio-economic environment
Onesua Storm Surge Repair	<p>There are no major water crossings structures along this section. This location is exposed to north east which is the main direction for storms and cyclones. The geology is low lying beach sand on recent limestone. There is an area of thermal springs under the northern section of the road.</p>	<p>Coastal, beach environment with pine, coconut and <i>Pandanus</i> trees dominating.</p>	<p>There are no existing houses or other buildings in between coastline and the road. On inland side there are no buildings or other structures within 40 to 50 m from the road edge.</p>

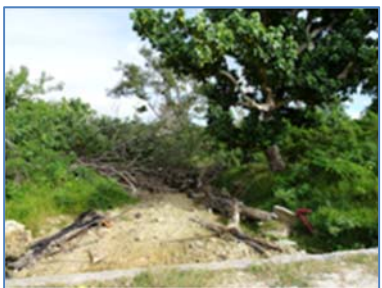
Sara Culvert	<p>This culvert is located along the coast. The geology is low lying beach sand on recent up lifted limestone. The channel near the culvert is dominated by tidal flows with a small intermittent catchment of freshwater flows after rain.</p>

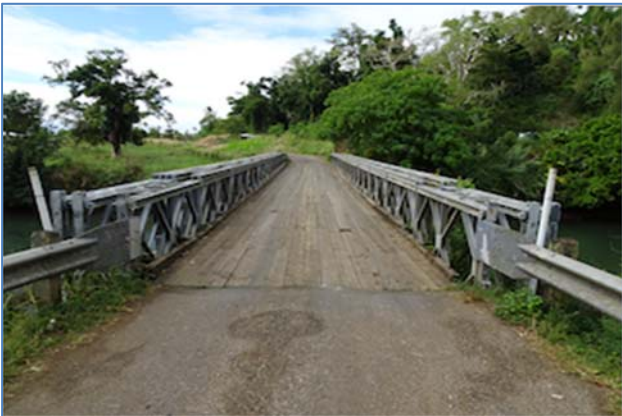
Epule Bridge	<p>Epule crosses a river that is relatively large approximately 10-15 km and deep enough for the use of kayaks and canoes. The geology at the bridge is recent up-lifted limestone but further upstream the source is in the older limestone.</p> <p>Channel is dominated by tidal flows with very good water quality. There was no evidence of sedimentation in the channel.</p>	<p>The area is well vegetated both up and downstream of the bridge. The coastal side of the bridge is mostly cleared and grassy, however, as it is private land. Inland, there are planted gardens along the north by the residence and further upstream.</p> <p>The river supports a diverse ecosystem of endemic fish and crustaceans such as eel fish and estuarine shrimp.</p>	<p>There is a residence to the northeast that rents out kayaks and does river tours. There is fenced off private land on either side of the bridge along the coast which is fenced using barbed wire.</p>

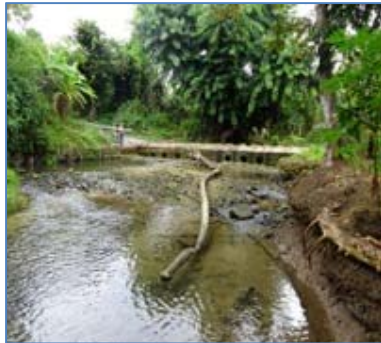
Sub project	Physical environment	Biological environment	Socio-economic environment
Epau Culvert	<p>The creek is wide but mostly shallow. Channel is dominated by tidal flows with a small catchment of permanent freshwater flows.</p> <p>Bank erosion is evident downstream and gabion walls have been installed for a portion to prevent this</p>	<p>There is a large Banyan tree adjacent to the culvert, otherwise the immediate surroundings are fairly clear.</p> <p>There is likely habitat for endemic freshwater fish and crustaceans</p>

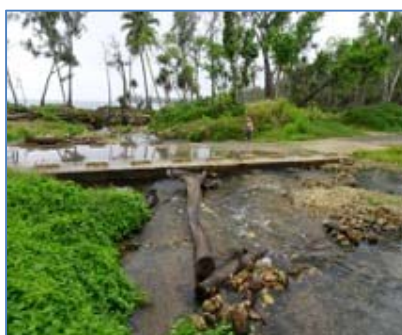
<p>There are no nearby sensitive receivers. A few houses upstream along the stream but main village is about 300m</p>
Neslep Culvert	<p>The culvert is located on the coast on a creek that widens near the mouth. Channel is dominated by tidal flows with a small catchment of permanent freshwater flows. There are small amounts of sediment building up which are sufficient to block the small pipe culverts.</p>	<p>Upstream vegetation is composed of tall grasses and weeds adjacent to the culvert and mature trees further up.</p> <p>Downstream, the vegetation is coastal with coconut and pine trees. Fallen trees remain.</p> <p>There is likely habitat for endemic freshwater fish and crustaceans</p>	<p>There are no nearby sensitive receivers.</p>

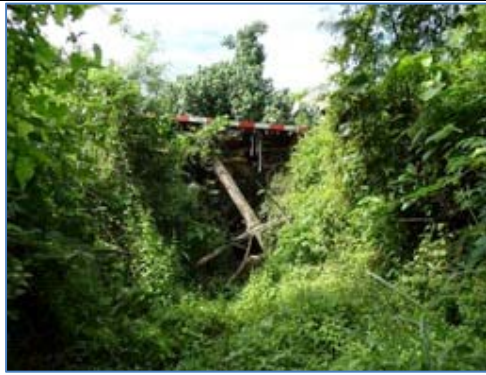
Lamin Bridge	<p>Lamin is ~100m from the coast. Channel is dominated by tidal flows with a small catchment of semi-permanent freshwater flows. There is little evidence of erosion and sedimentation.</p> <p>No freshwater flow observed</p>	<p>Vegetation upstream is dominated by coconut and banana trees with considerable weed infestation in the channel, while the vegetation downstream is more coastal. Lots of weed infestation in the channel itself.</p> <p>There is likely habitat for endemic freshwater fish and crustaceans</p>	<p>There are no nearby sensitive receivers.</p>

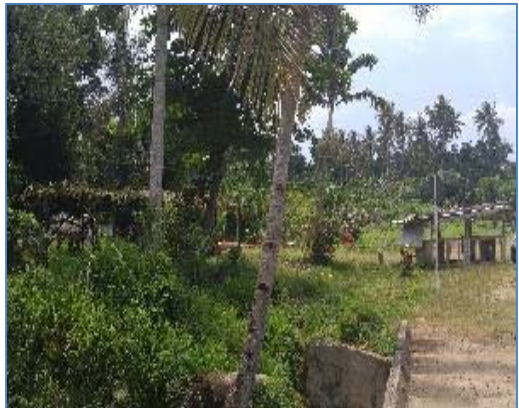
Pangpang Bridge	The watercourse Forari river is narrow and flowing. There is small area of alluvium underlain by recent limestone. There were no visible signs of sedimentation and deterioration of water quality. The river has a more extensive upland catchment and sources from volcanic geology and the area of a significant manganese deposit.	<p>The area directly around the watercourse are heavily vegetated and relatively pristine. North of the bridge, near the village, the land has been cleared.</p> <p>There is likely habitat for endemic freshwater fish and crustaceans</p>

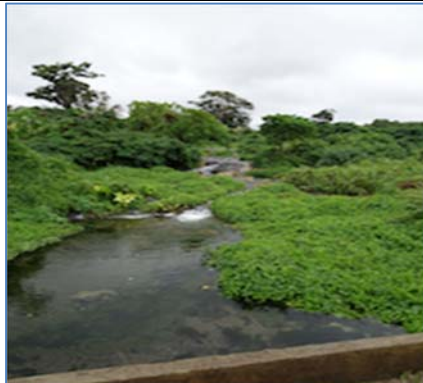
La Cressonniere Culvert	<p>The watercourse is wide and shallow with a fast moving flow.</p> <p>There were recently completed/ongoing earthworks during the October site visit. The site is located on a steep geological boundary between the older raised</p>	<p>The vegetation has been cleared around the culvert and vegetation is dominated by tall grasses and weeds; with palm and banana as well as some mature trees present further up and downstream. There are visible algal blooms which may be</p>	<p>This watercourse is used for a tourist destination and benches have been provided in the downstream area for guests to sit with their feet in the water. The sudden change in geology is an interesting tourist and education location.</p>

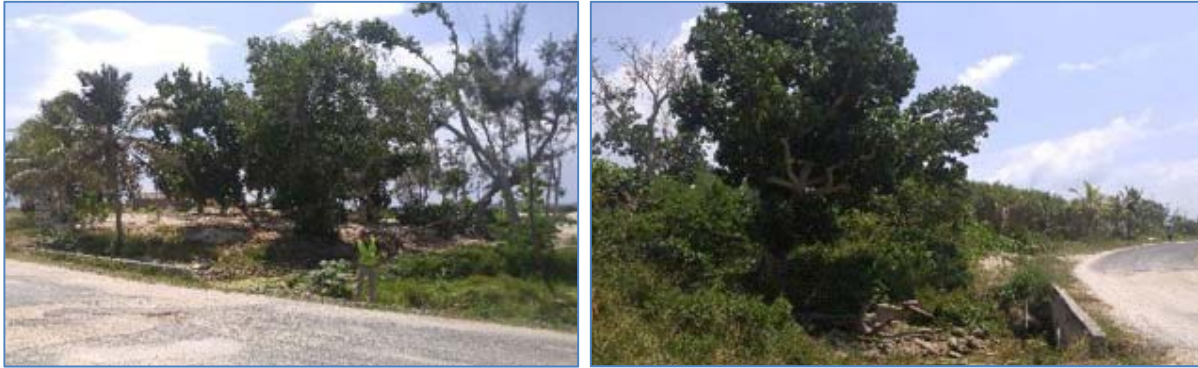
Figure 4-5 Onesua Storm Surge Repair existing environment

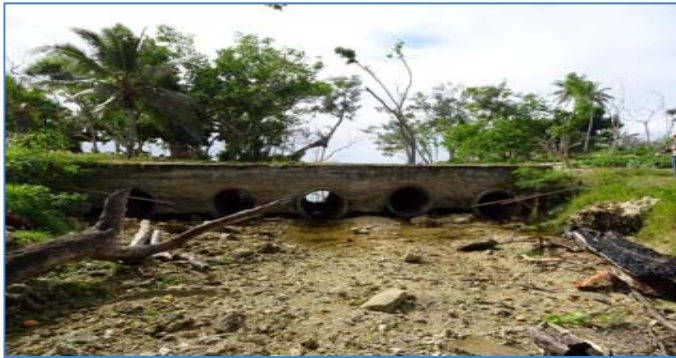
Figure 4-6 Sara Culvert existing environment

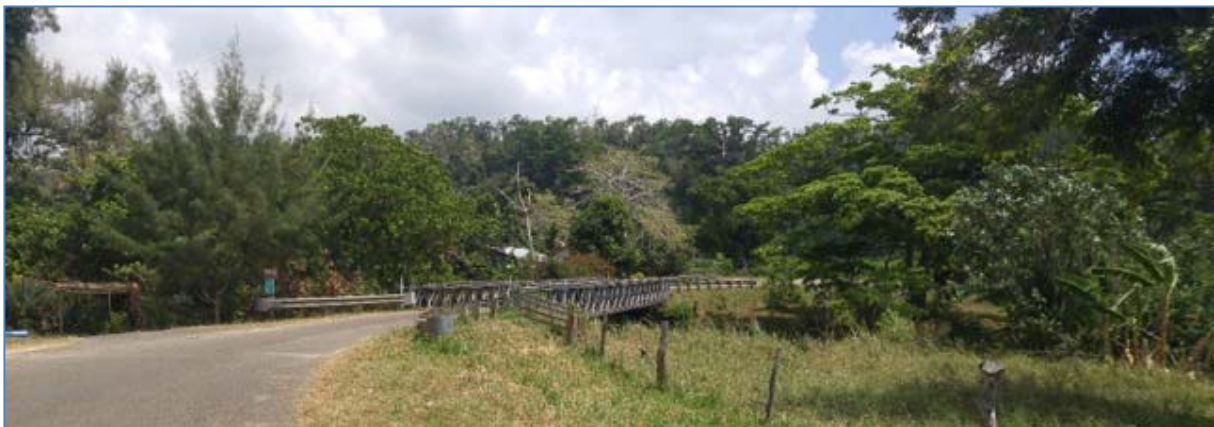
Figure 4-7 Epule Bridge existing environment

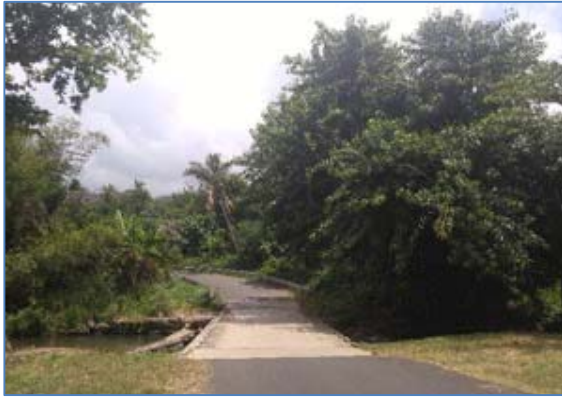
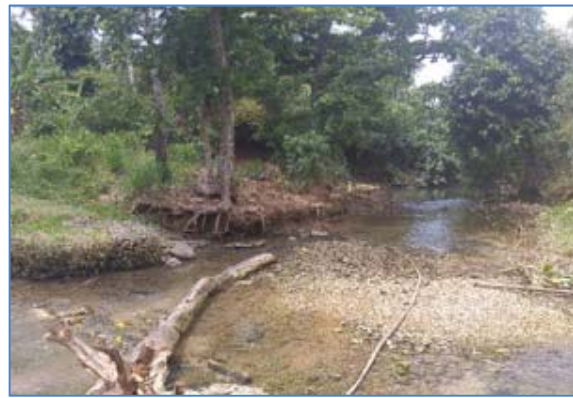
Figure 4-8 Epau Culvert existing environment

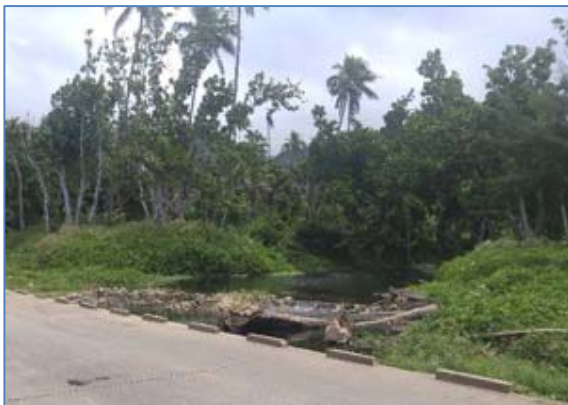
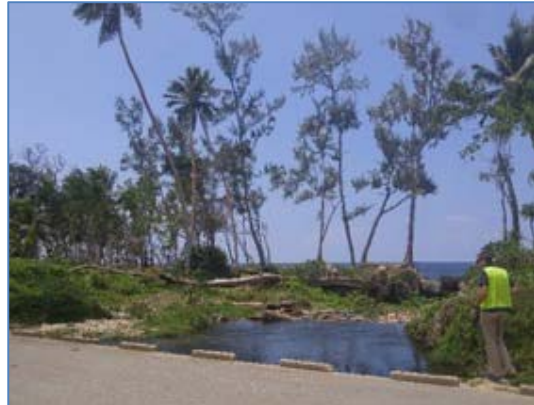
Figure 4-9 Neslep Culvert existing environment

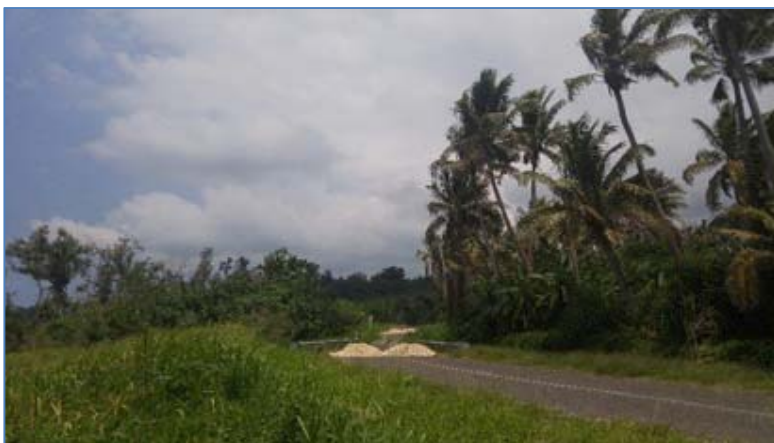
Figure 4-10 Lamin Bridge existing environment

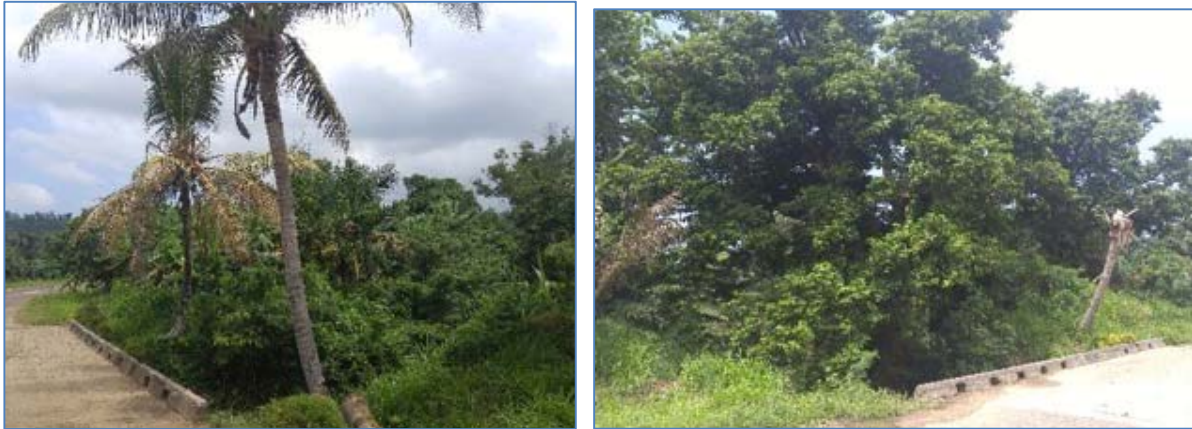
Figure 4-11 Pangpang Bridge existing environment

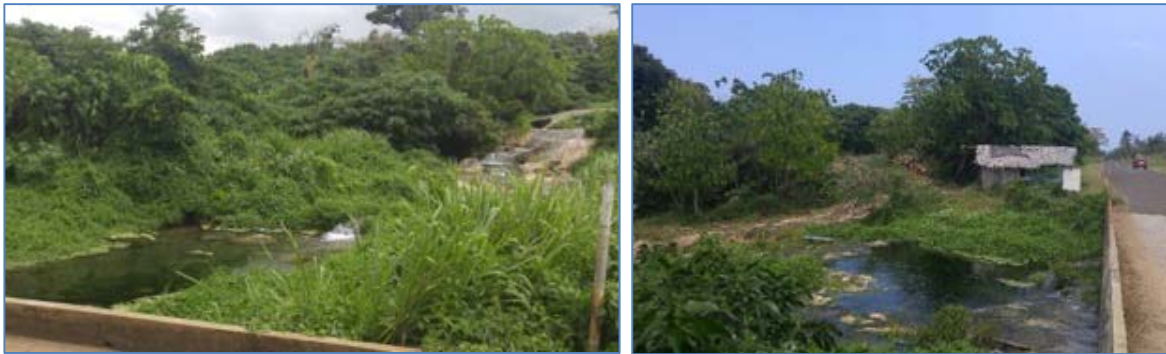
Figure 4-12 La Cressonniere Culvert existing environment

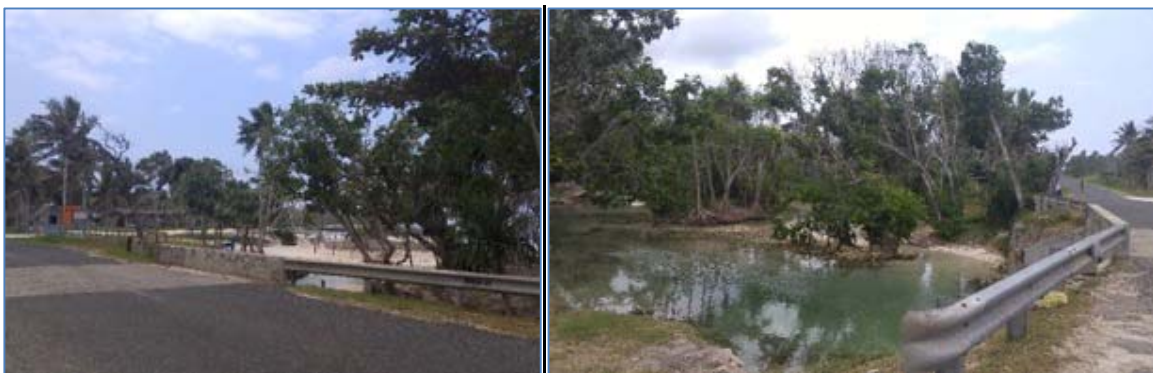
Figure 4-13 Eton Beach Culvert existing environment

Eton Beach Culvert	Low Coastal topography on recent up lifted limestone. The channel flows from a back dune estuary with brackish water supporting endemic estuarine saltwater fish and crustaceans.	The environment is dominated by mangrove, pandanus and isolated canoe tree species.	There is a tourist beach nearby that is run by the community for an entrance fee.

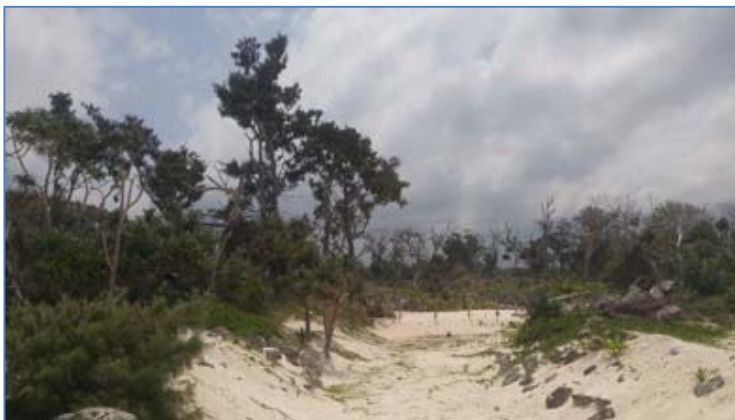
Figure 4-14 Eton Dry Creek Culvert existing environment

Eton Dry Creek Culvert	Low Coastal topography on recent up lifted limestone. Windblown sand has damaged the existing bridge and approaches,	The environment is dominated by mangroves species to the west. On the east, it is white sand beach with pandanus and isolated tall canoe trees	There a tourist beach nearby that is run by the community for an entrance fee. Illegal sand clearing is a current land use problem

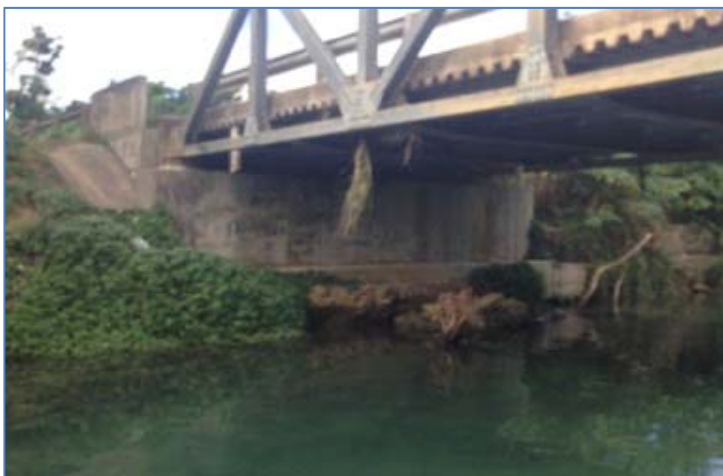
Figure 4-15 Rentapau Bridge existing environment

Rentapau Bridge	<p>Geology is old limestone so channel is very stable with little obvious erosion and sedimentation. The river has an extensive upstream and is relatively large compared to the other eastern subprojects.</p>	<p>The area is well vegetated along the River. It is a highly modified environment with secondary vegetation including many weeds</p>	<p>There are residents south-west of the bridge, although the entrance is further down the road and is not visible from the bridge.</p>
